NIST Special Publication 901

The January 17, 1995 Hyogoken-Nanbu (Kobe) Earthquake

*Performance of Structures, Lifelines, and Fire
Protection Systems*

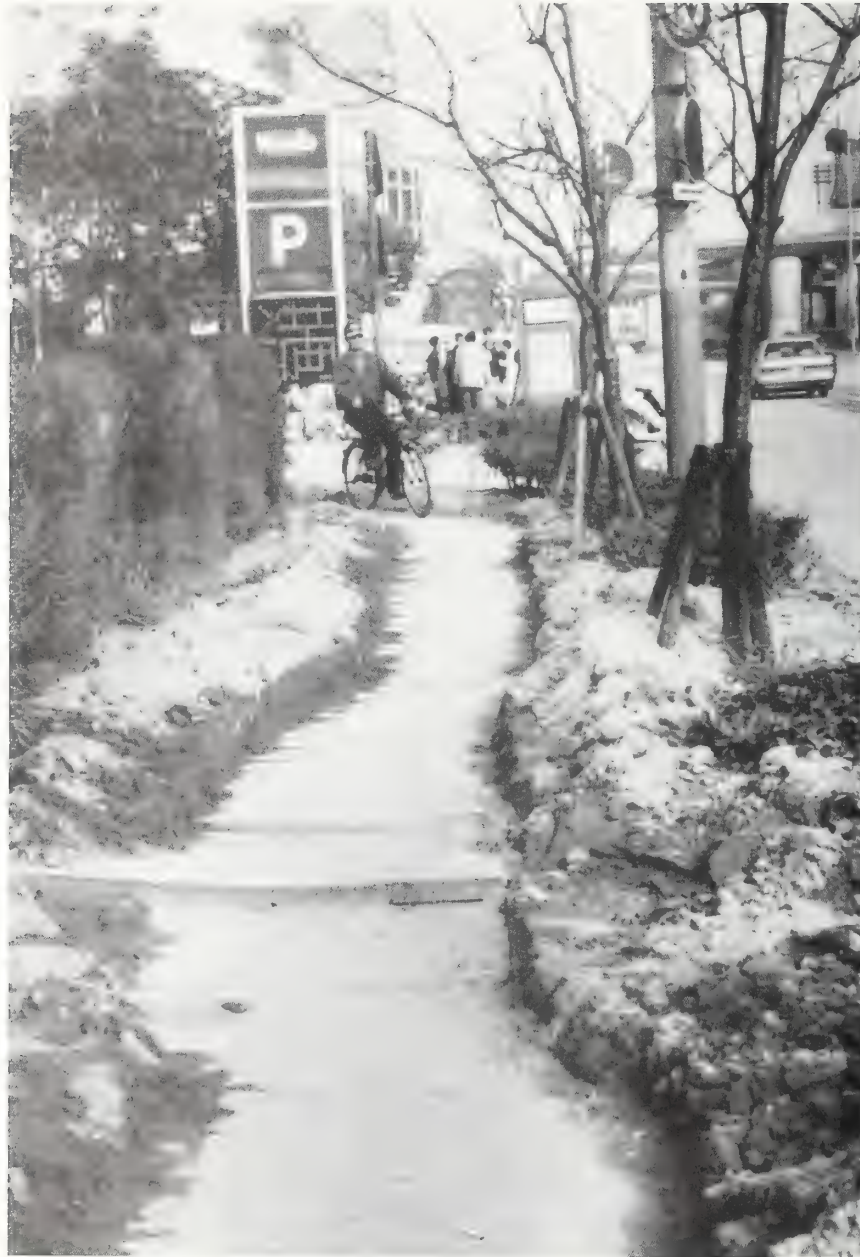
Figure 2.5.1 Path cleared through soil vented by liquefaction that covered sidewalk on Port Island (Photograph by Carol S. Prentice, USGS).

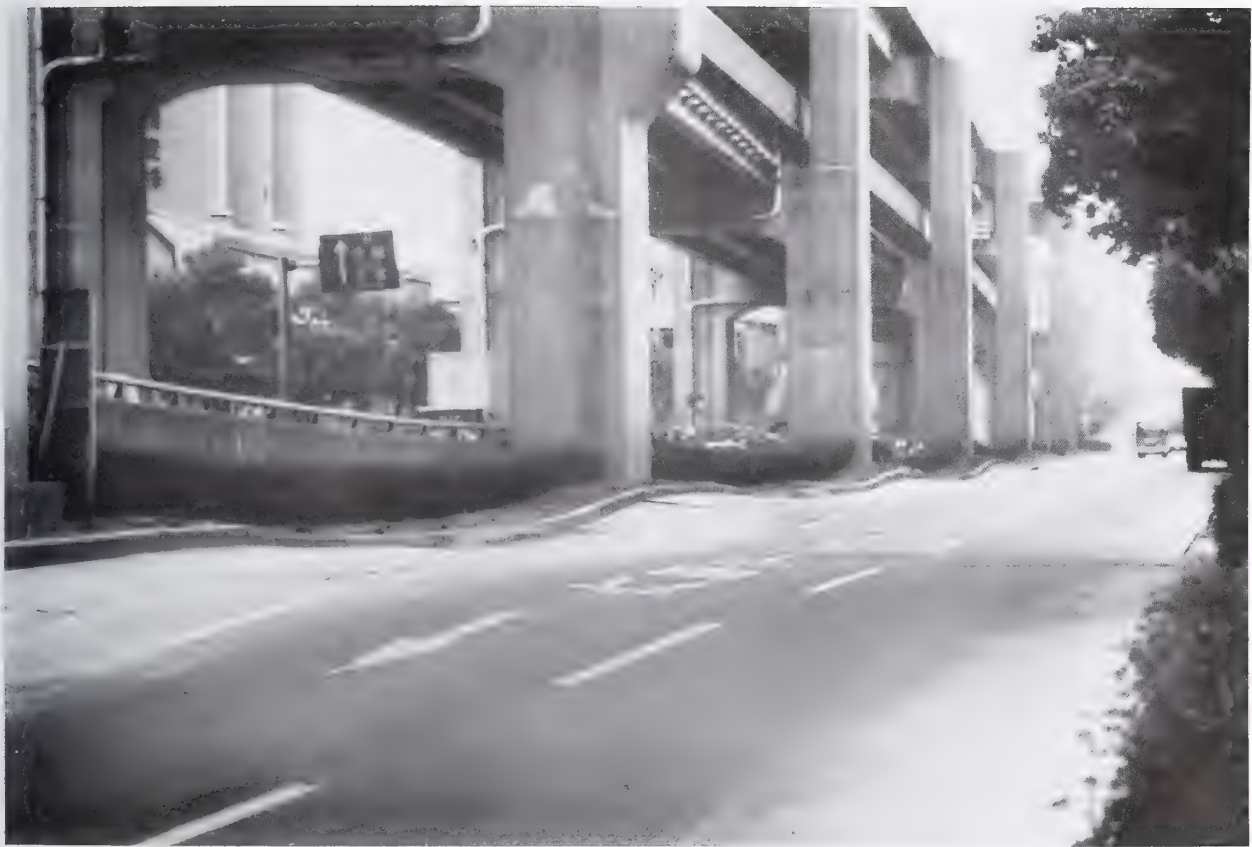
Figure 2.5.4 Differential ground settlement in artificial fill along the Harbor Freeway. Post-liquefaction consolidation cause ground to settle between bridge columns. Columns extend through the liquefied zone. (Photograph by Carol S. Prentice, USGS).

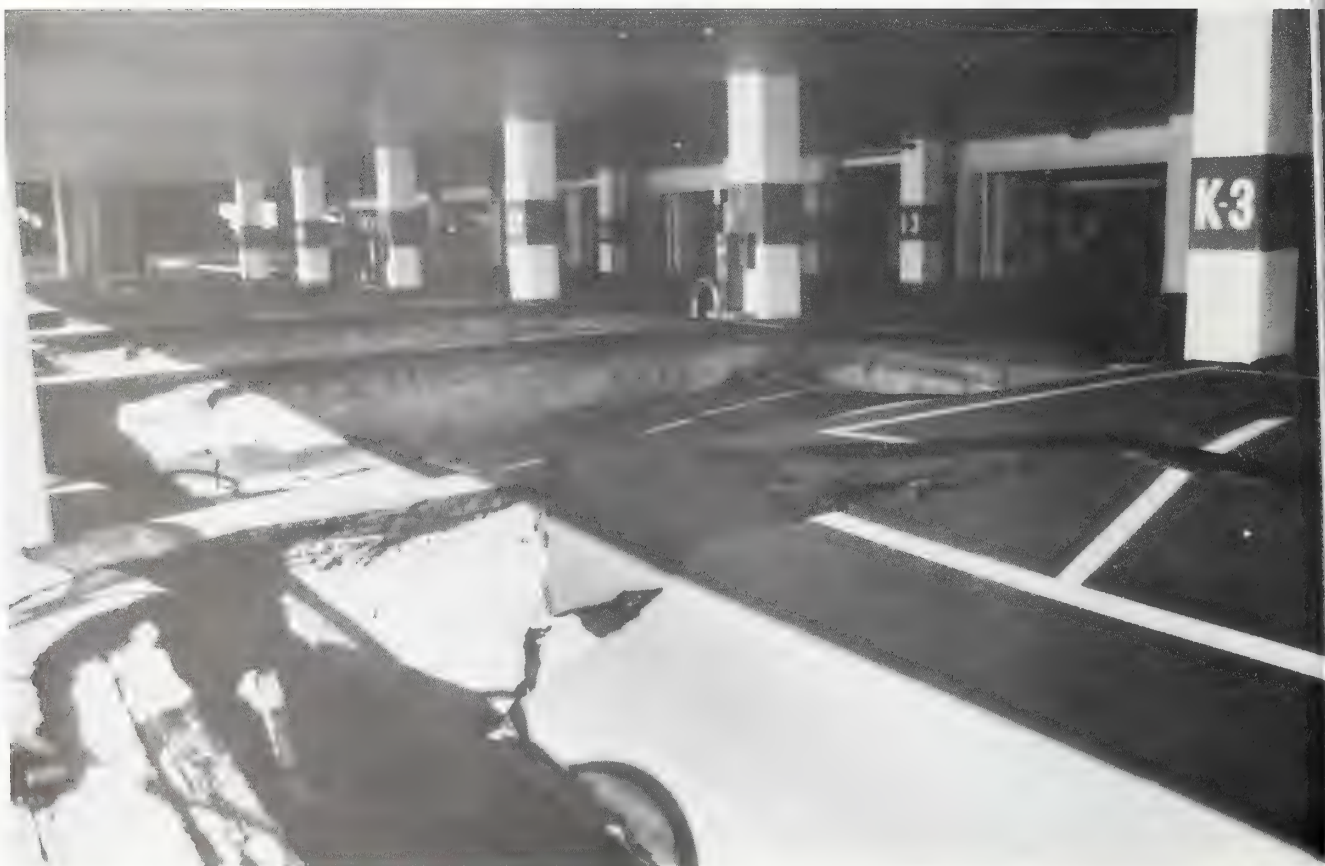
Figure 2.5.5 Differential settlement of about 1 m between columns of parking structure on reclaimed ground near the bridge to Port Island.

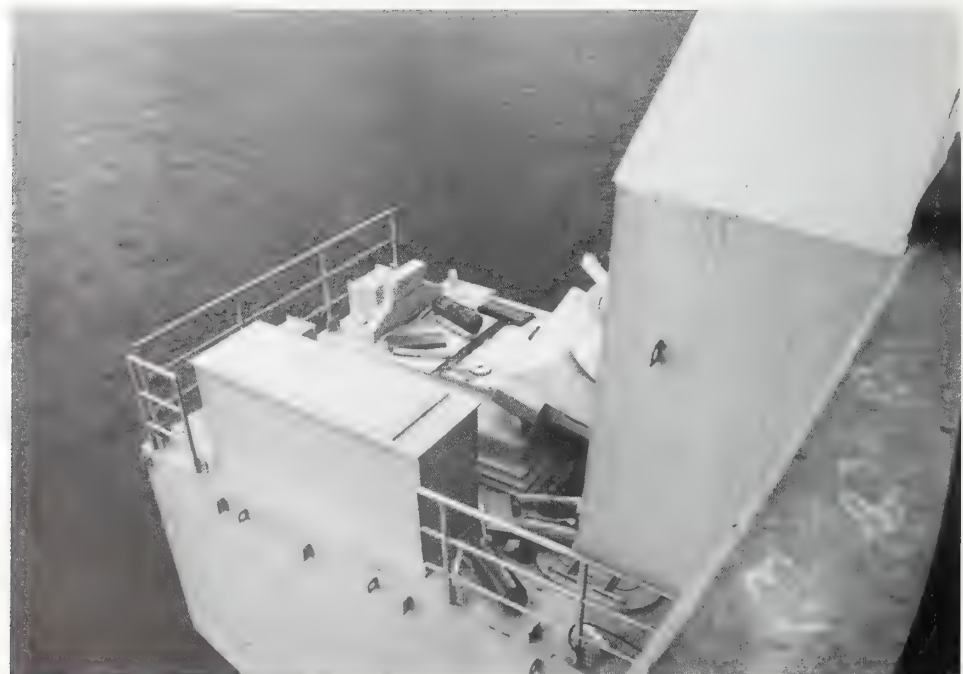
Figure 4.2.6 Damaged expansion bearing and lateral offset of west face of South Pier, Rokko Island Bridge.

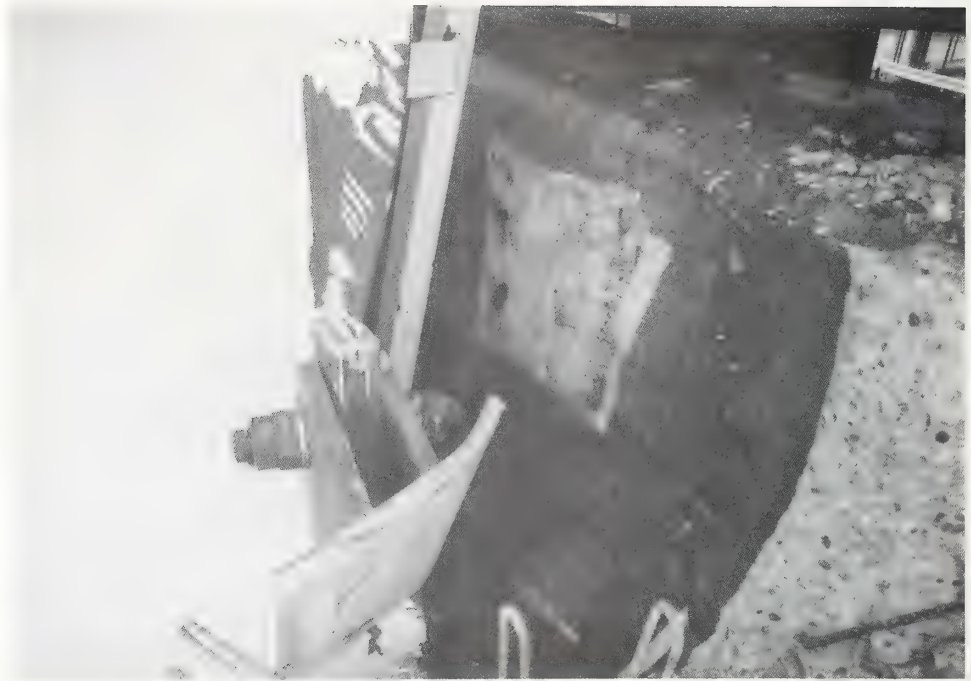
Figure 4.2.11 Damaged restrainer at Abutment A1, Mukogawa Bridge, showing failure of anchor bolts and distortion of web of main girder.

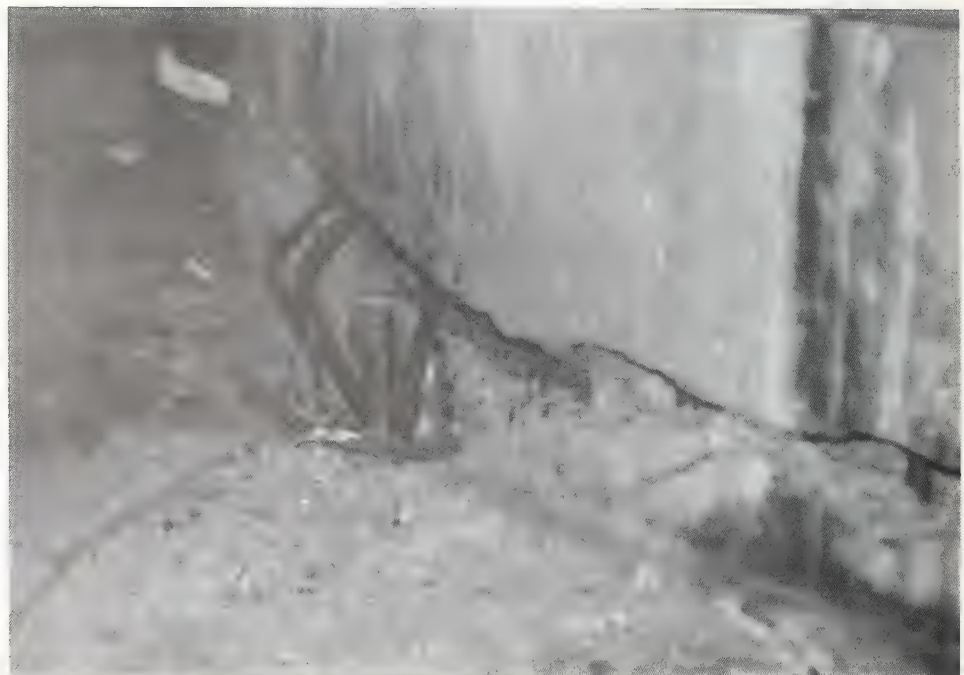
Figure 4.2.12 Failure at top of buried column, Pier P1, Mukogawa Bridge.

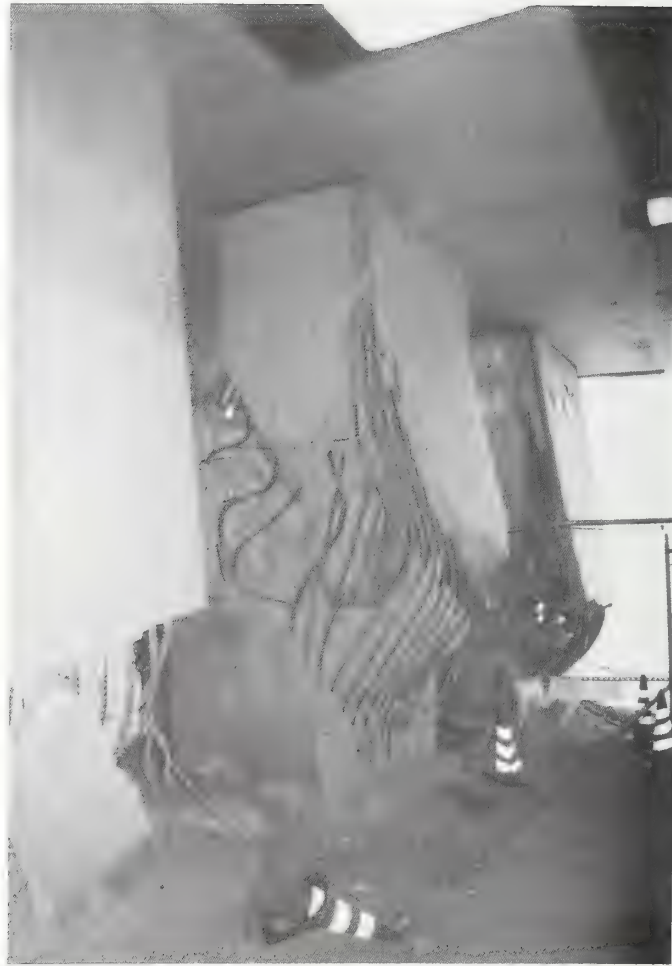
Figure 4.2.22 Shear failures in 3-column bent at Pier 3, Takarazuka Viaduct.

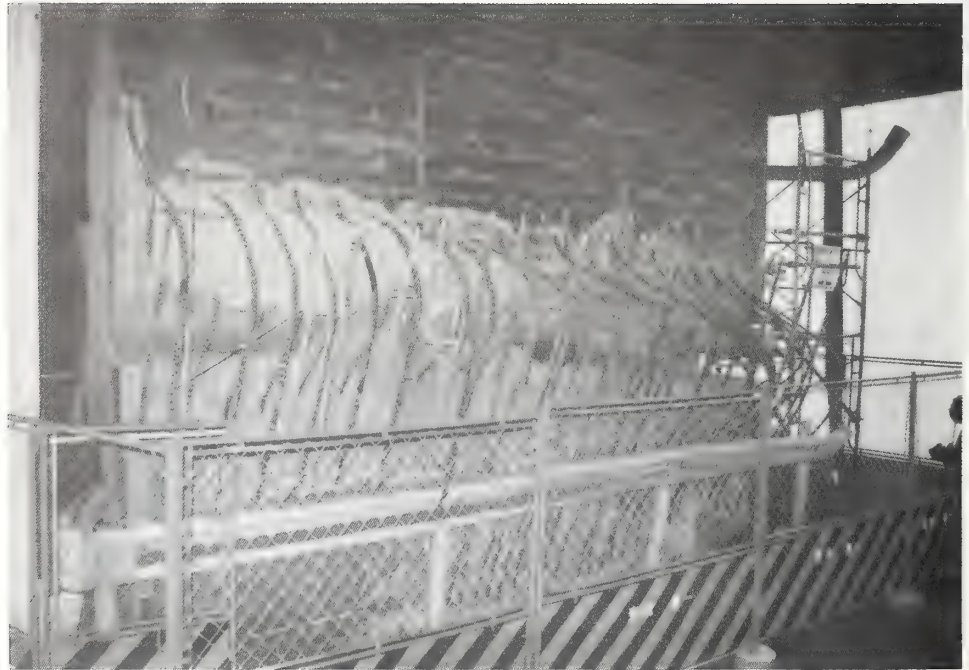
Figure 4.2.24 Shear failure in wall pier (east face), Moribe Viaduct.

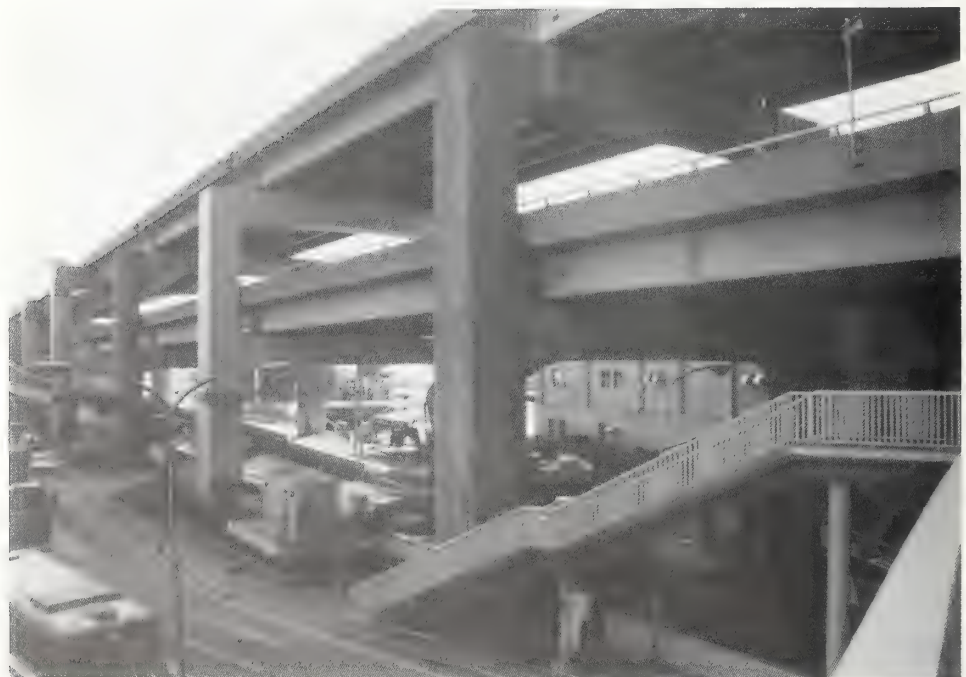
Figure 4.2.25 General view of Kobe-Ohashi Connector near Port Island showing formation of flexural hinges in lower level columns.

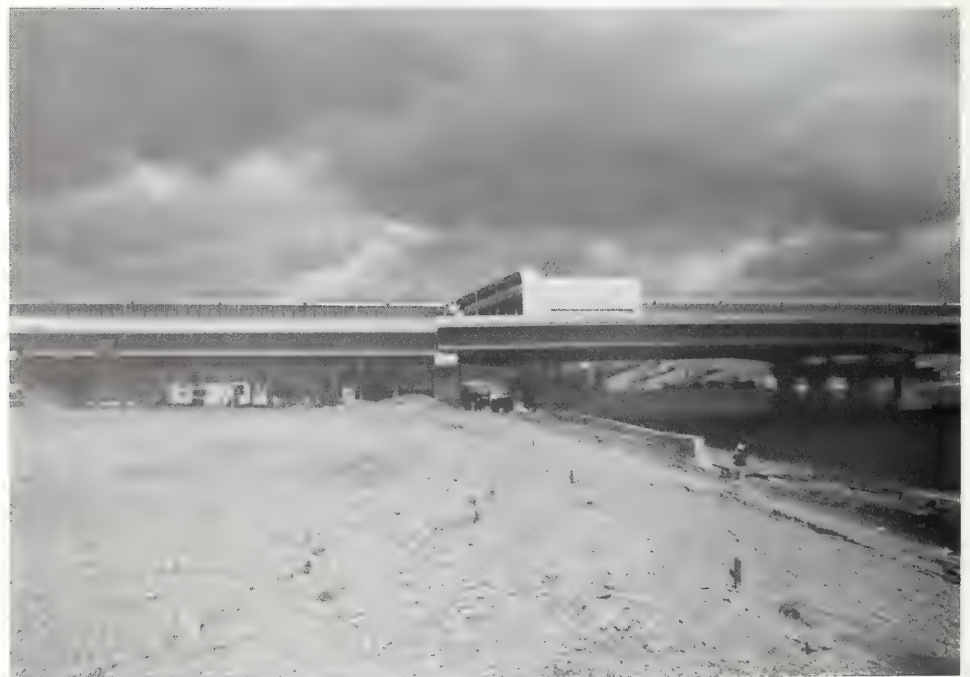
Figure 4.2.42 Distant view of the Shukugawa Bridge showing lateral deformation of the foundation soils and spreading to the right (to the center of the channel).

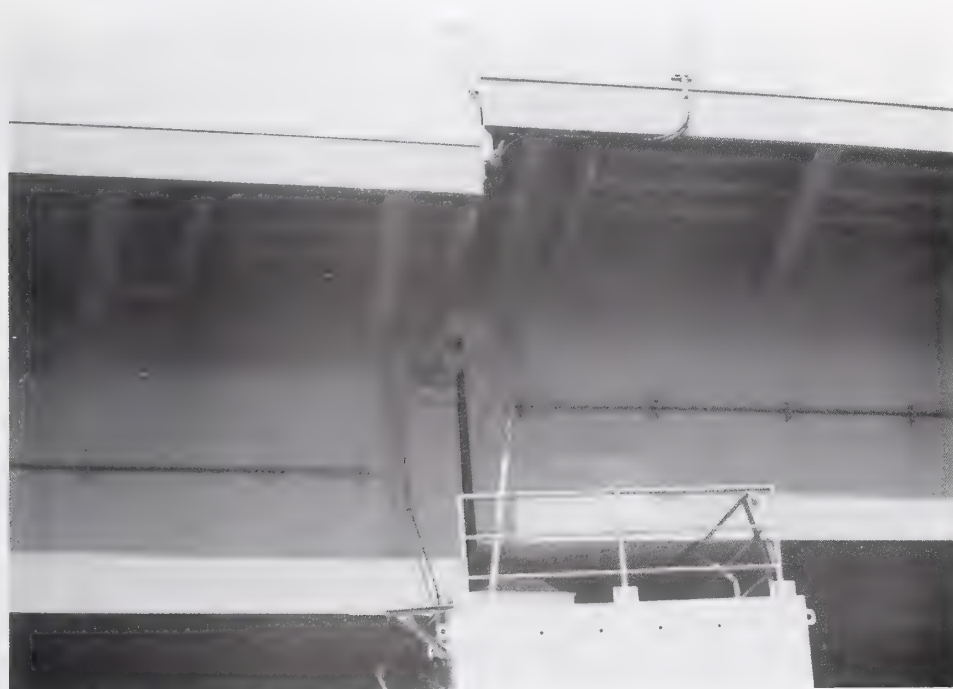
Figure 4.2.44 Approach span at edge of seat at Pier 134 of Shukugawa Bridge due to lateral movement of the pier by about 1 m towards the center of the channel.

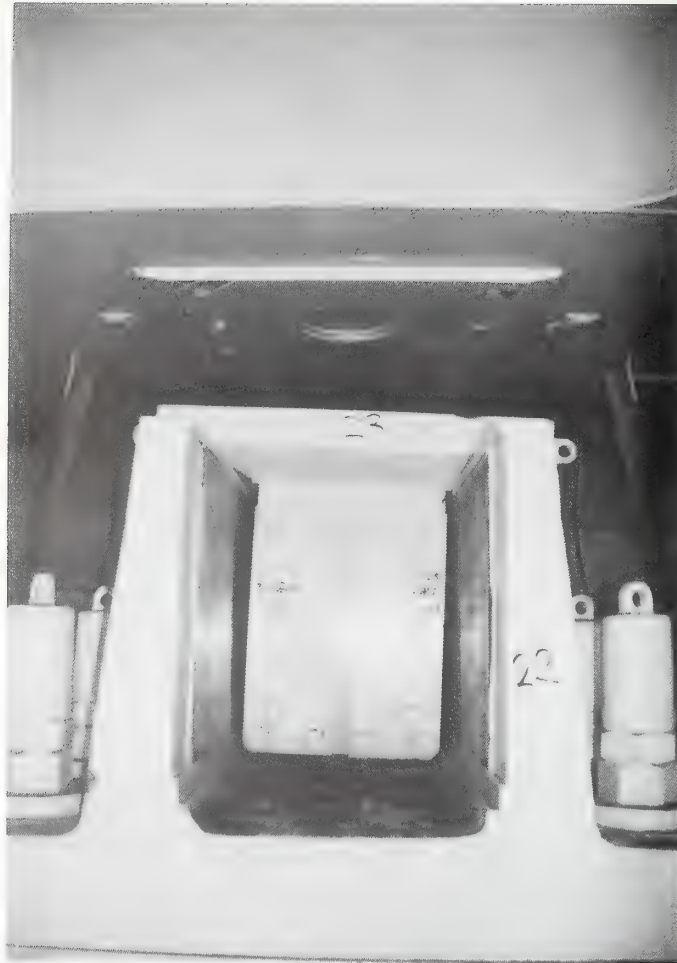
Figure 4.2.48 Failed wind shoe at Pier 187 of the Higashi-Kobe Bridge.

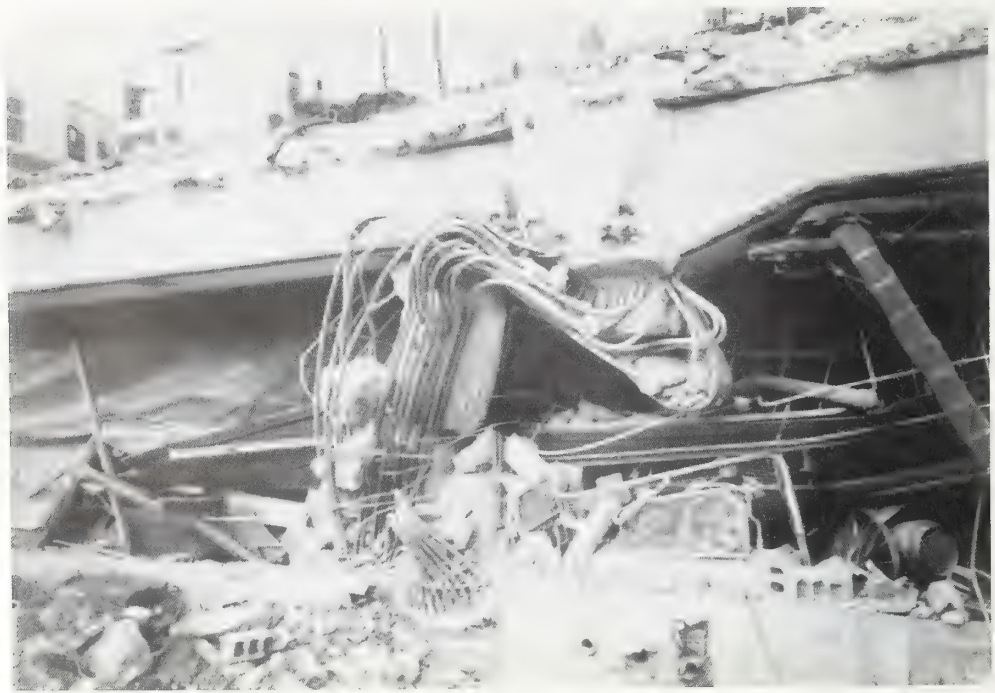
Figure 4.3.9 Failed column at Higashi - Nada - elevated rail yard.

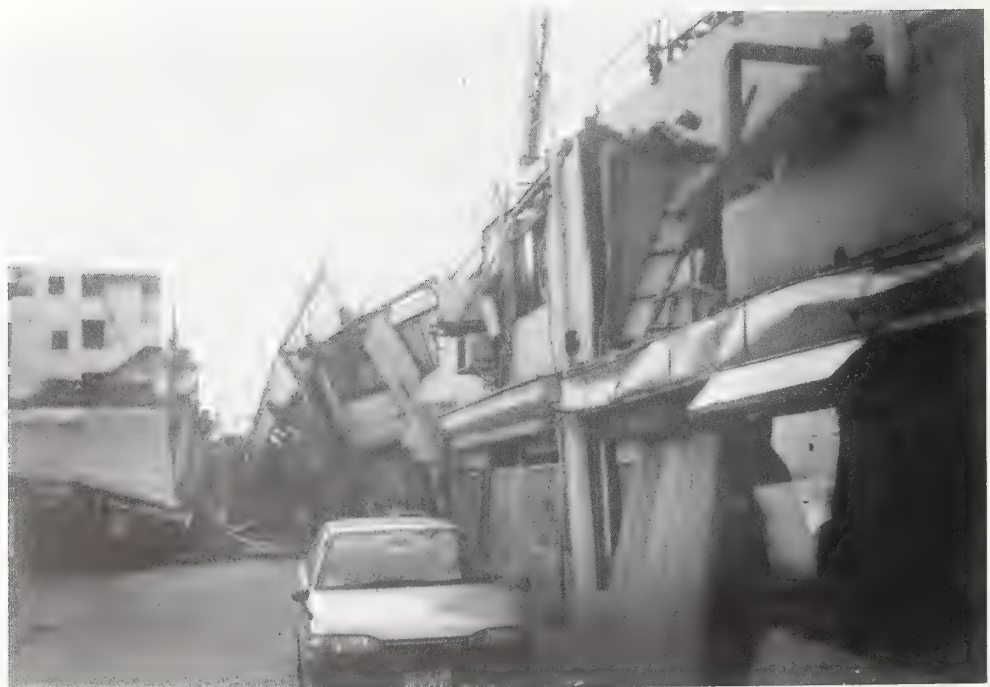
Figure 4.3.10 Collapsed rail yard at Higashi - Nada.

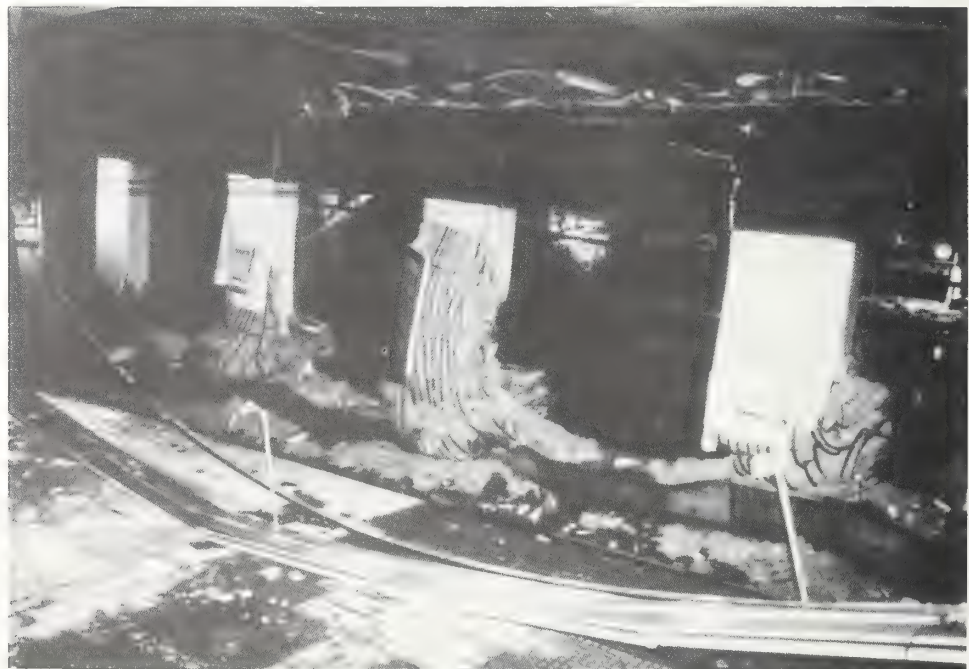
Figure 4.3.20 Compressive failure of center columns at Daikai Station.

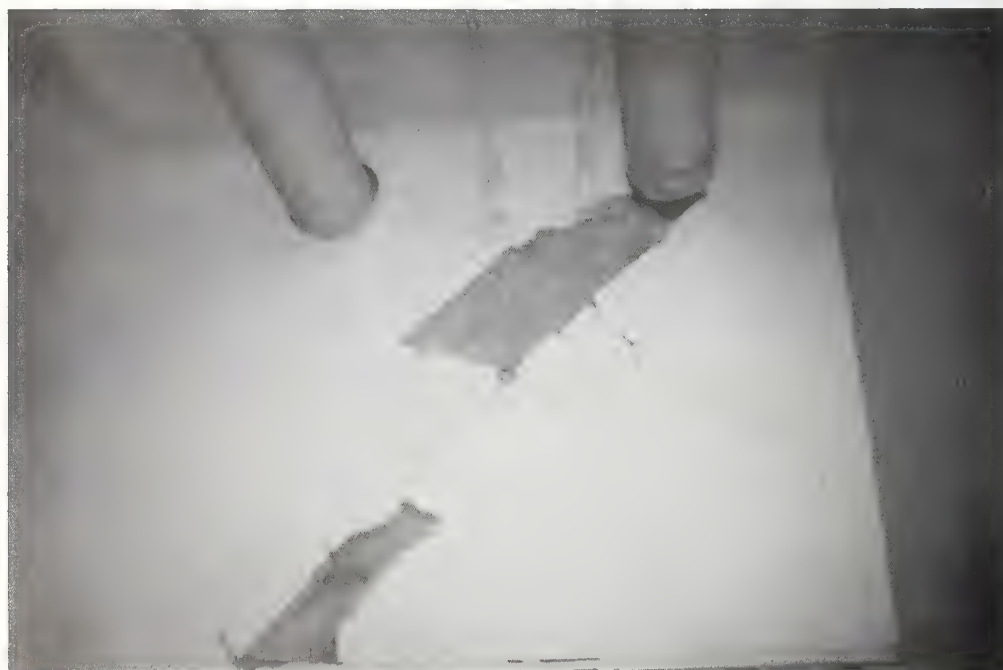
Figure 4.4.27 Cracks in the stair-well shear walls of the Osaka Airport Administration Building.

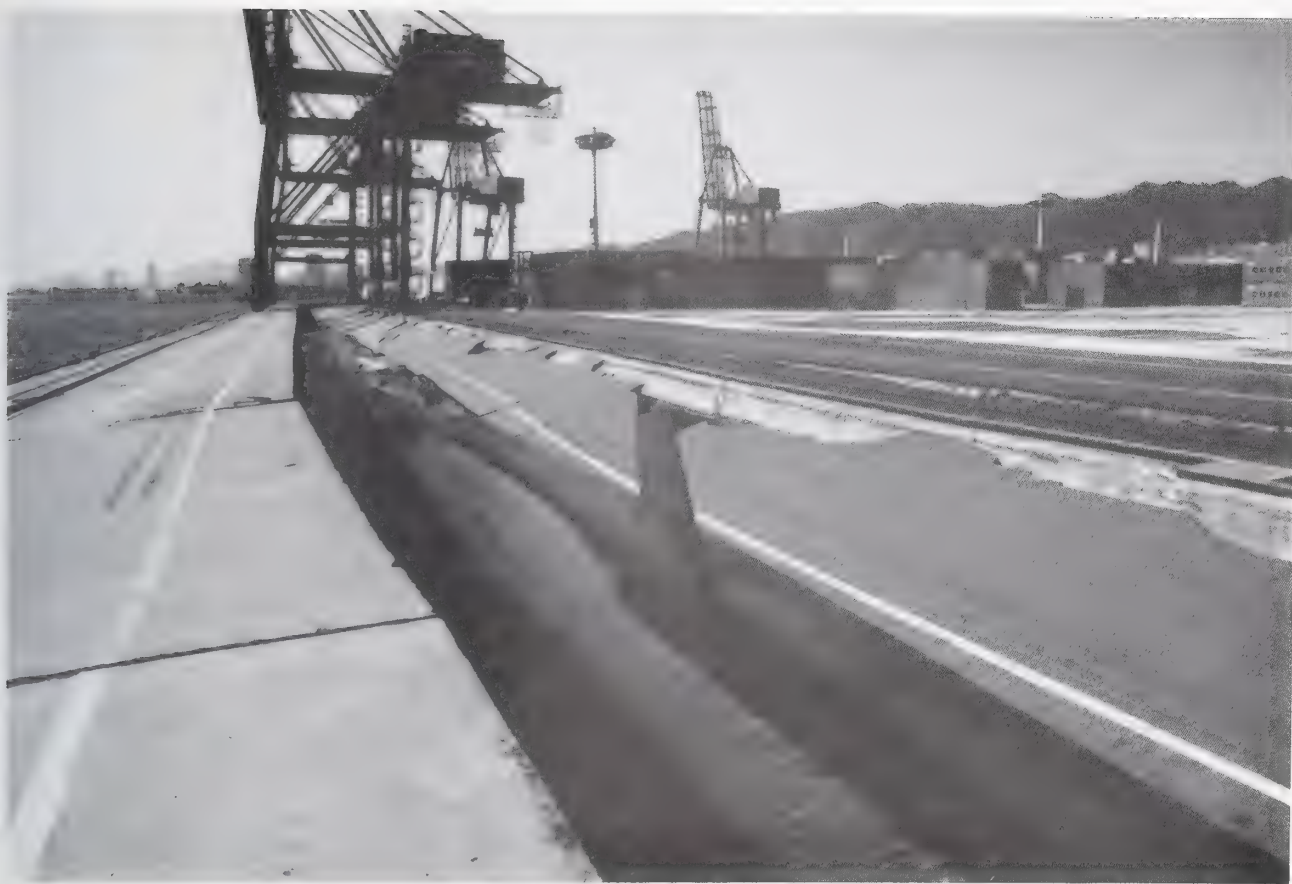
Figure 4.5.5 Damaged to Maya Wharf caused by liquefaction-induced lateral spreading. Downdropped block has formed behind quay wall where land has settled and moved outward. Landward side of block is the pile-supported rear crane rail. Photograph taken February 15, 1995.

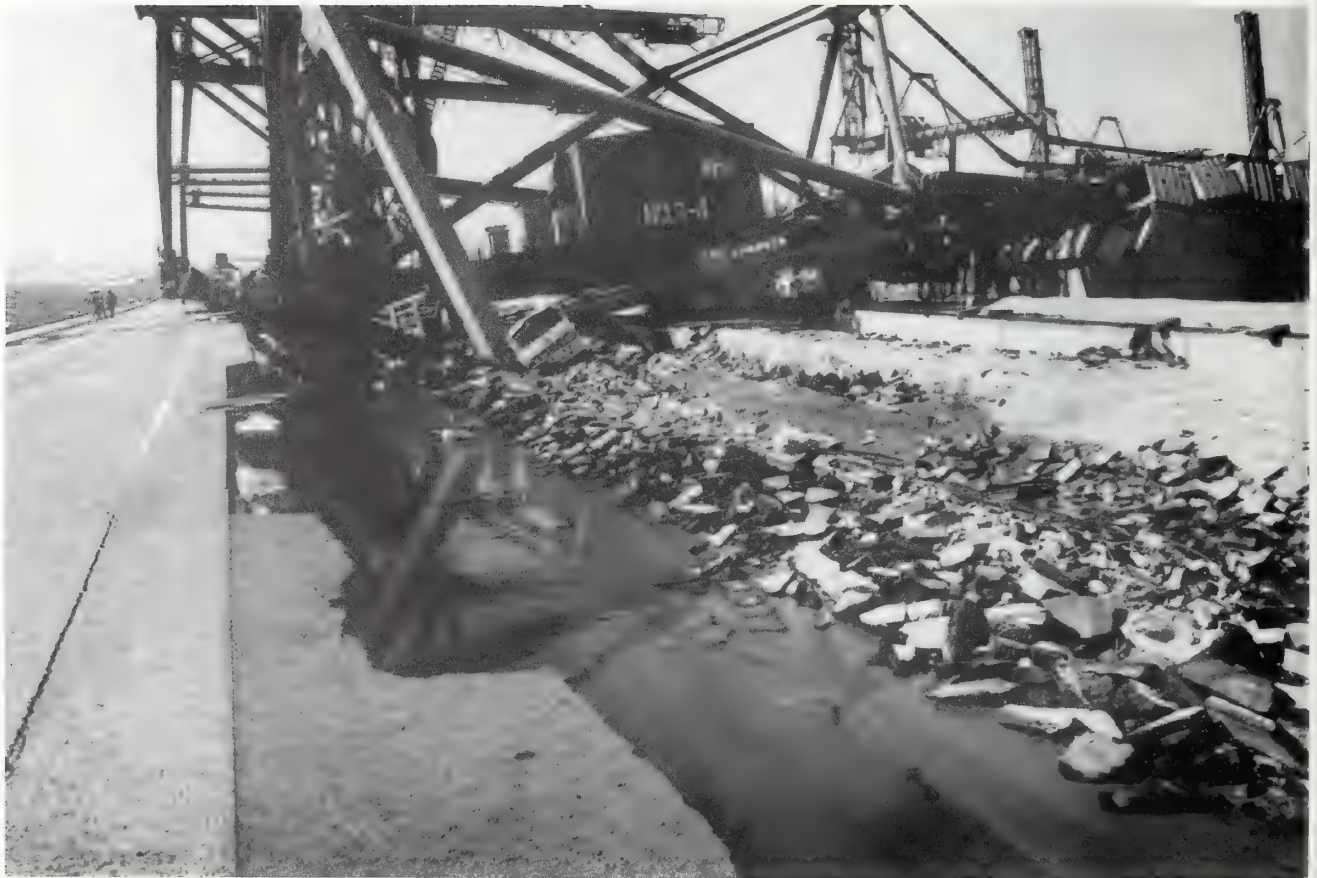
Figure 4.5.6 Collapsed crane caused by permanent differential horizontal displacement between crane rails on Rokko Island. Lateral spreading caused permanent seaward displacement of quay wall and crane rails to pull apart. This caused the legs of the crane to pull apart and crane to topple. Photograph taken February 15, 1995.

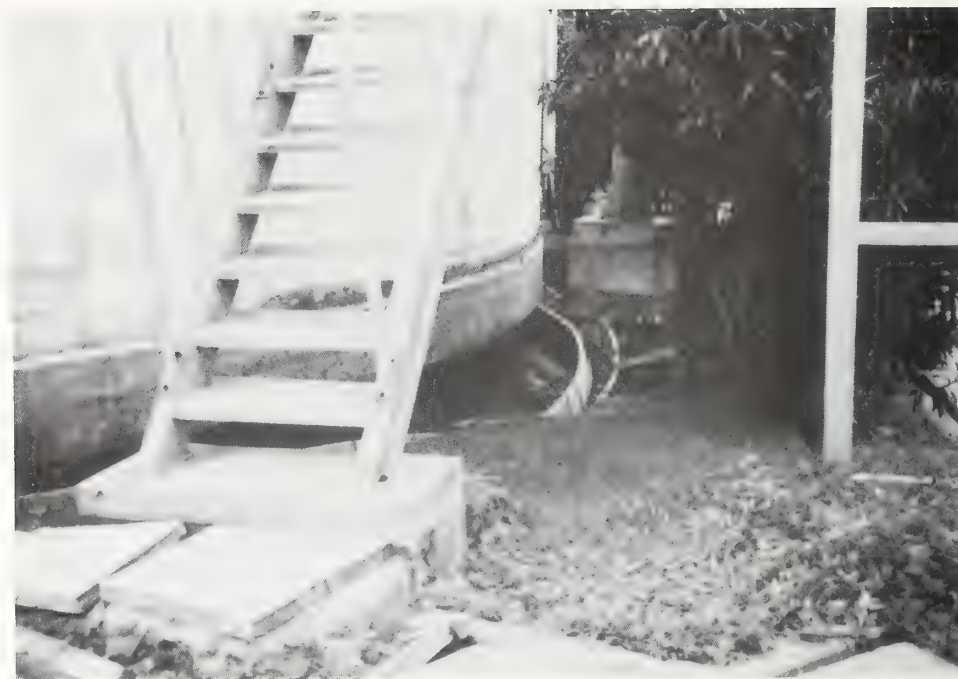
Photo 37 Differential settlement between pipe and non-pile supported structures damaged piping throughout the plant.

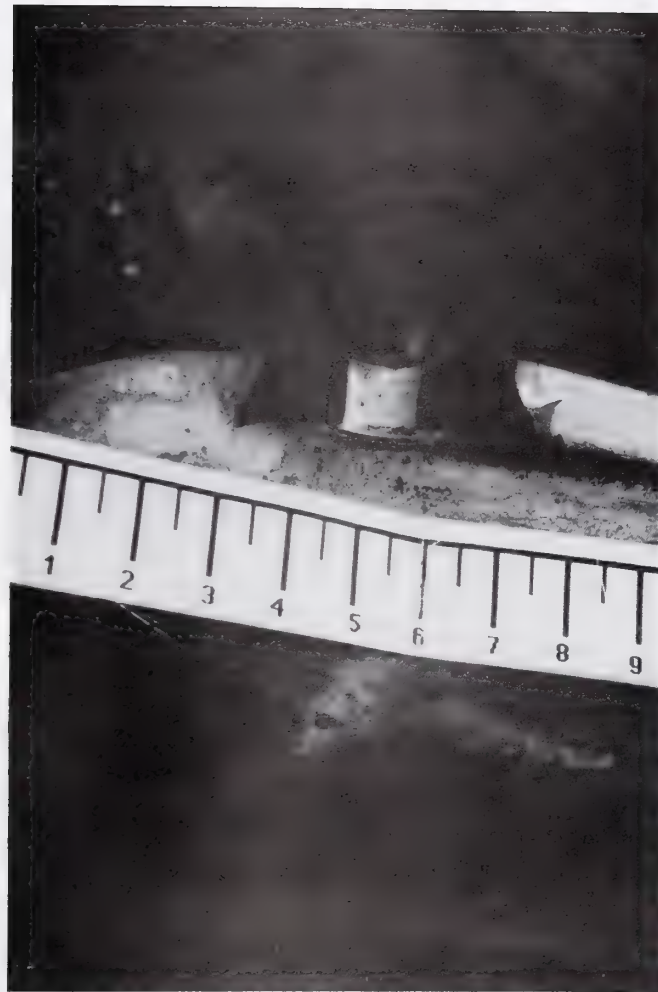
Figure 5.4.21 Failure of a current-voltage transformer base flange.

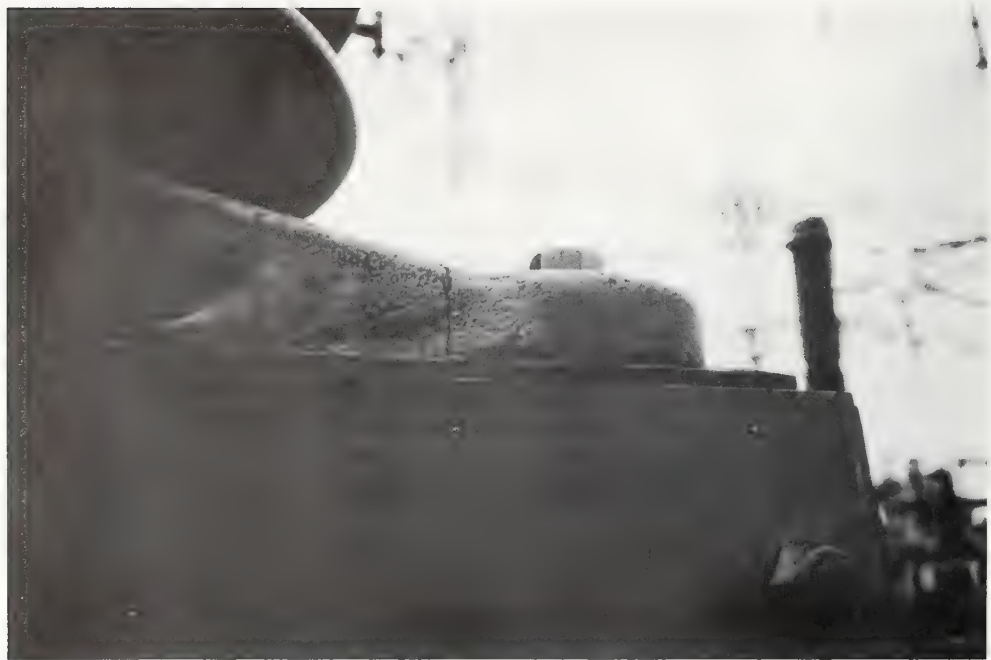
Figure 5.4.22 A cracked cast iron anchor tab on a current-voltage transformer remained in service.

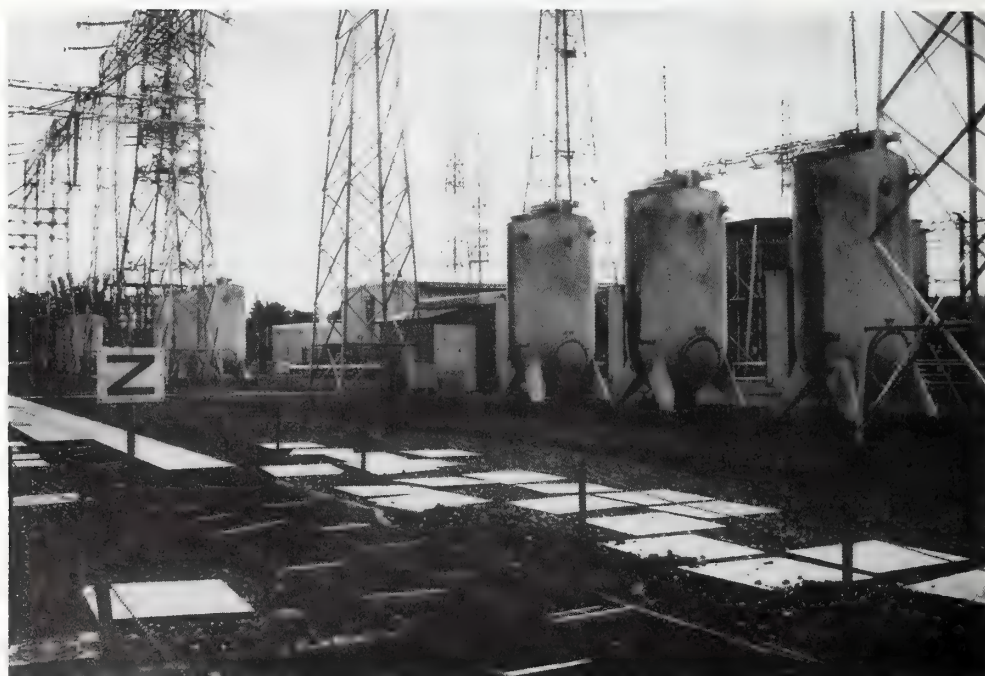
Figure 5.4.26 Bulk-oil circuit breakers with the bushings removed to replace damaged units at other sites.

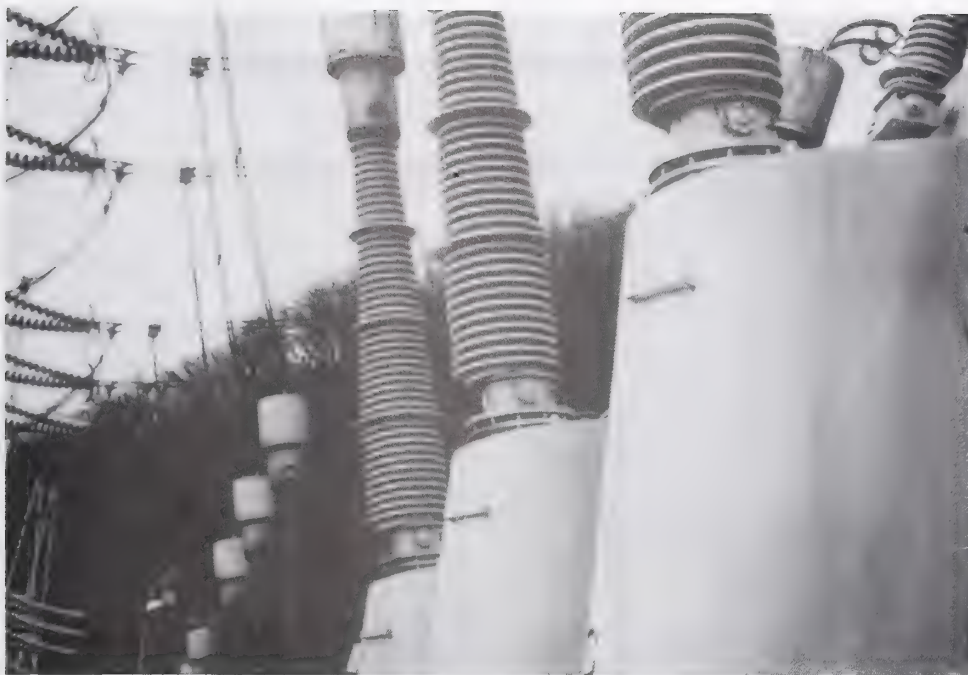
Figure 5.4.56 All three bushings shifted on this 275 kV bulk-oil circuit breaker.

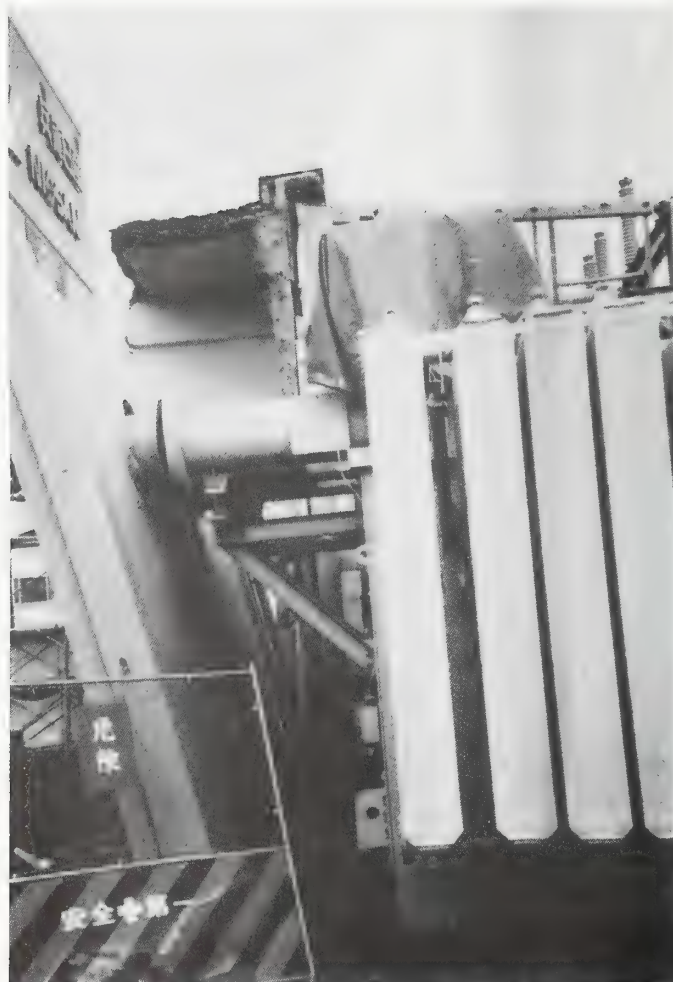
Figure 5.4.61 A transformer pushed over the fire wall after it failed its anchorage.

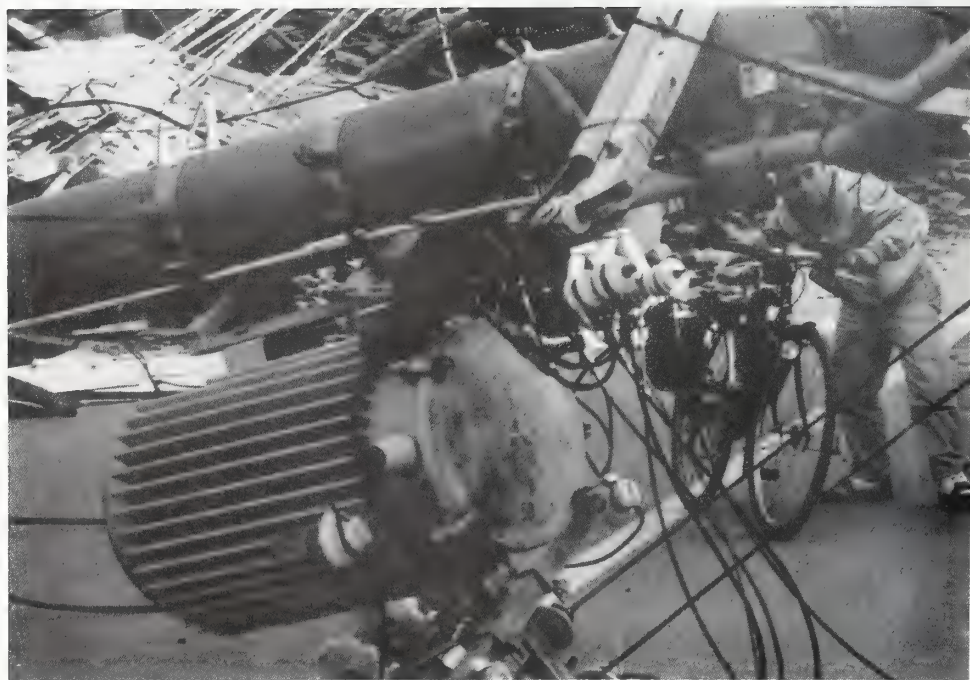
Figure 5.4.70 Fallen poles contributed to the disruption of traffic.

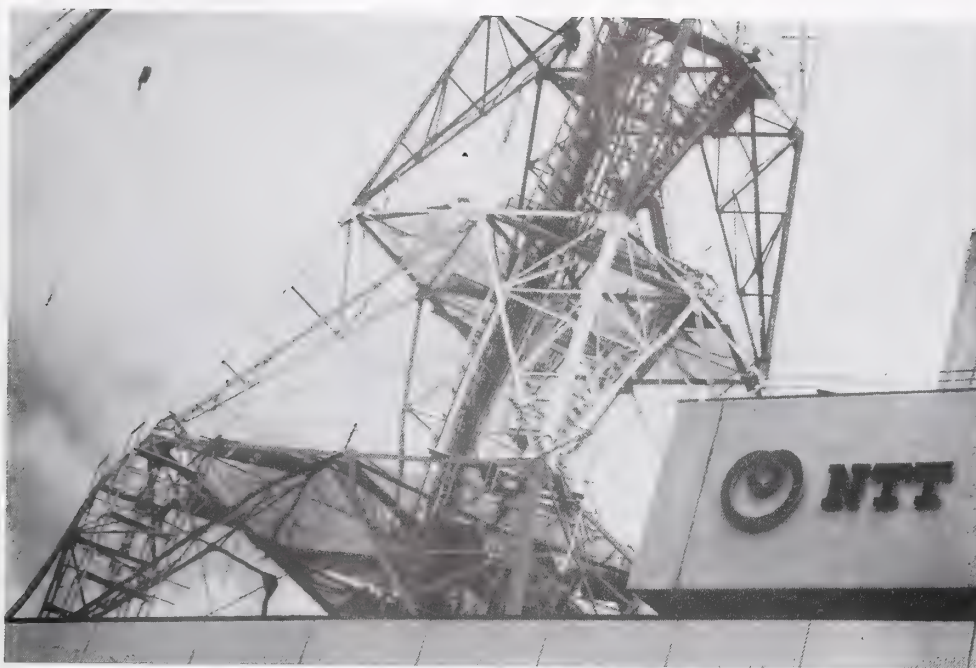
Figure 5.5.1 Microwave tower on top of a central office which was damaged and later removed.

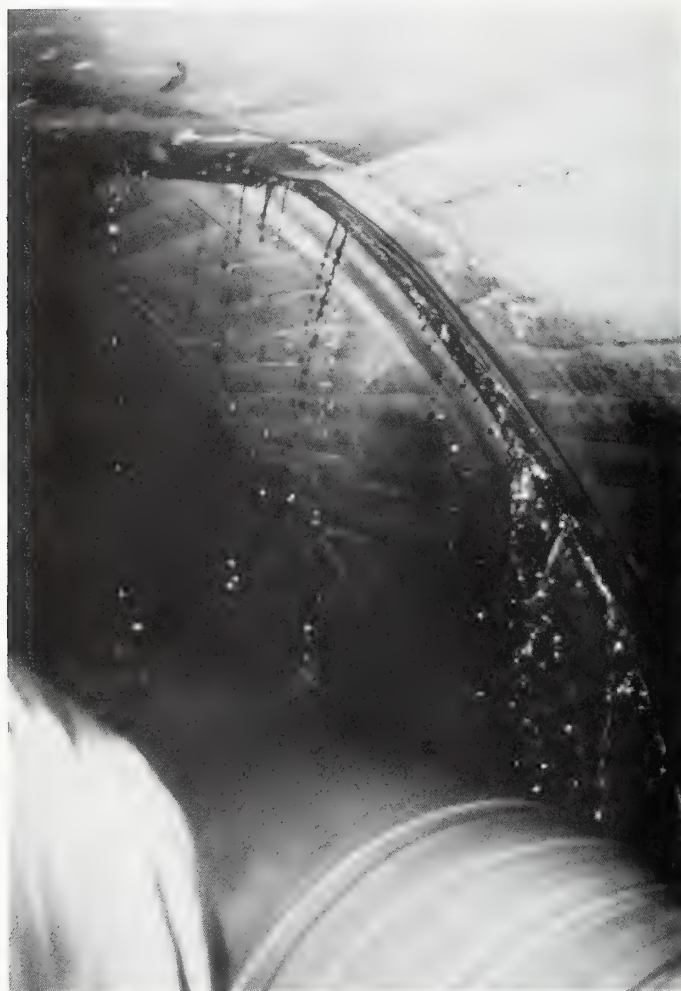
Figure 5.5.3

Slight movement at a construction joint caused a small water leak in a joint utility tunnel.

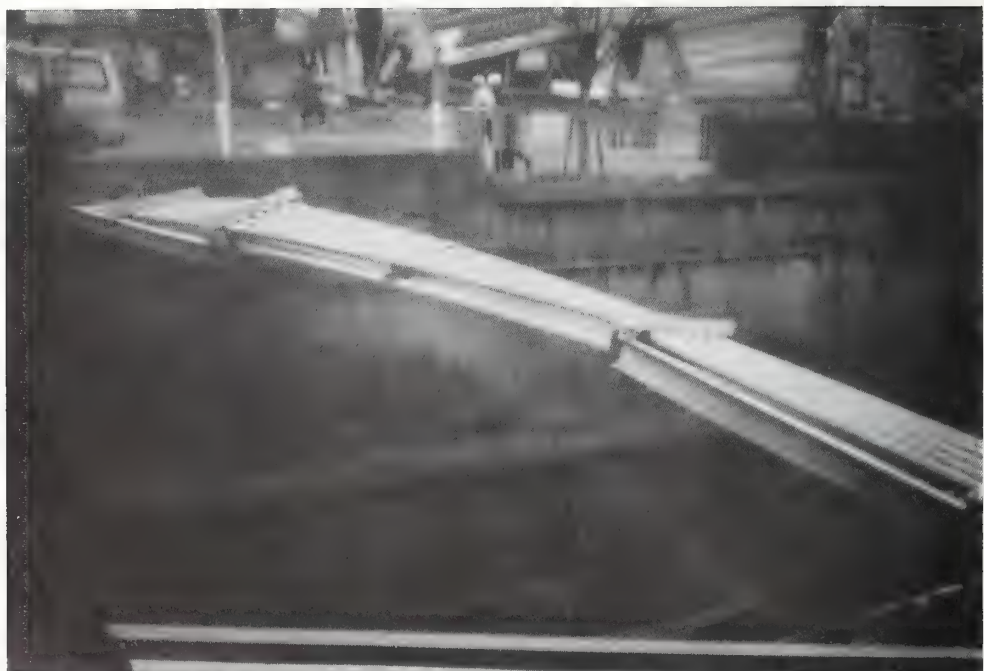
Figure 5.5.13 Walls of a canal moved causing conduit bridge and conduit to buckle.

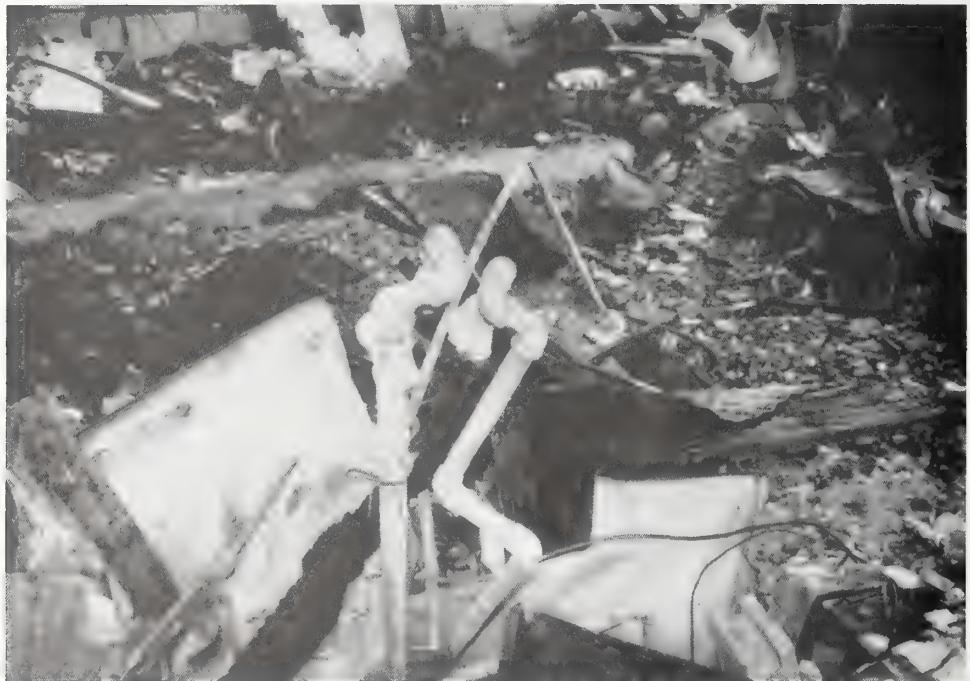
Figure 6.2.4 Broken gas meter connection.
